Course: PE 821 CE RETROFITTING AND REHABILITATION OF STRUCTURES

University College of Engineering, Osmania University

UNIT III

Condition Assessment, Non-Destructive Testing and Evaluation

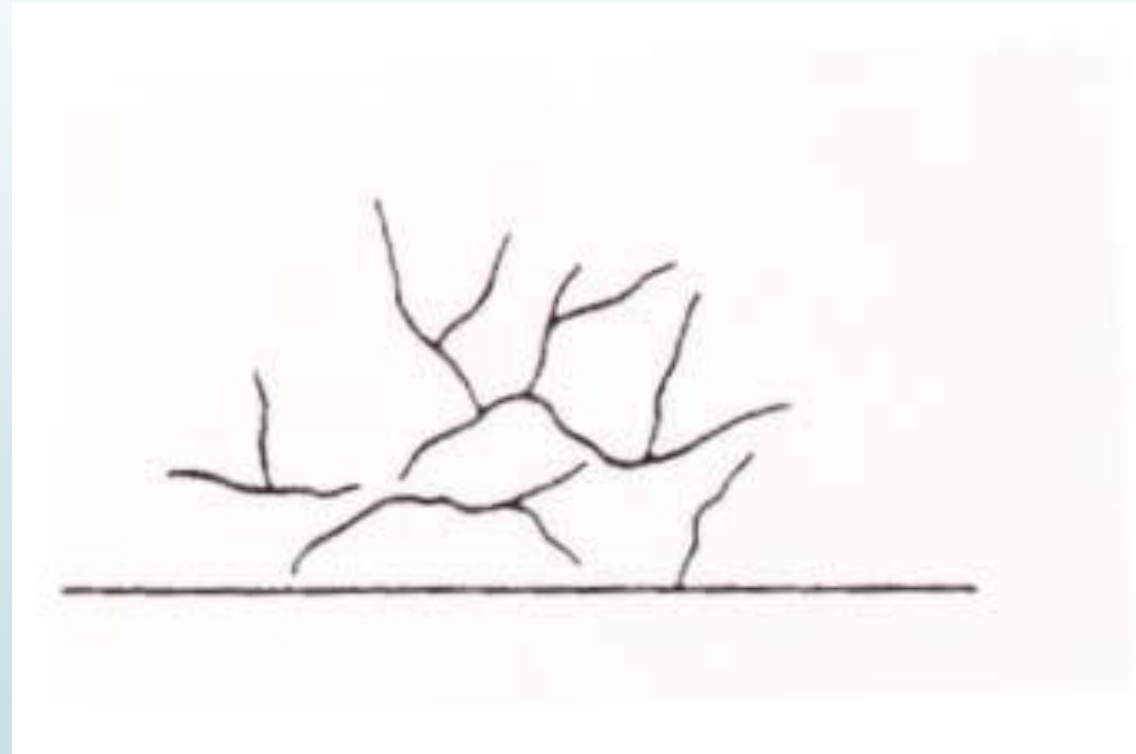
Fig. 1. Sketch of surface appearance when concrete has been mixed for too long or the time of transport has been too long.

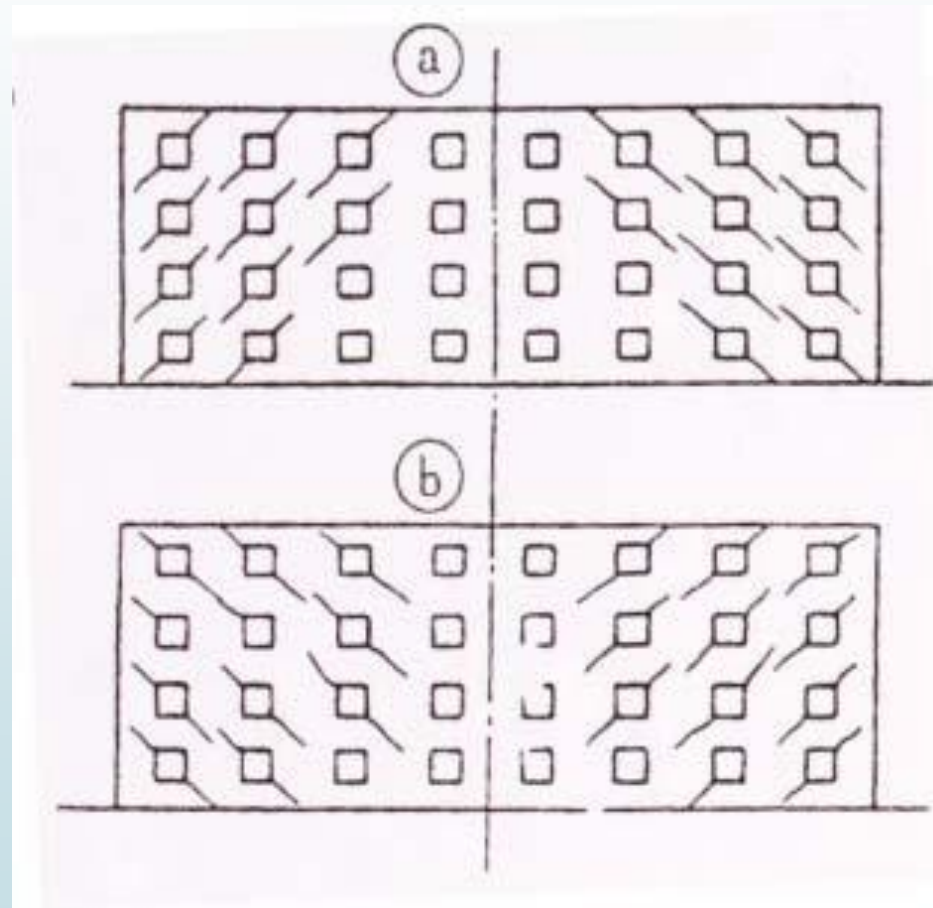
Fig. 17. Effect of changing ground conditions (a) low temperature (b) dryness

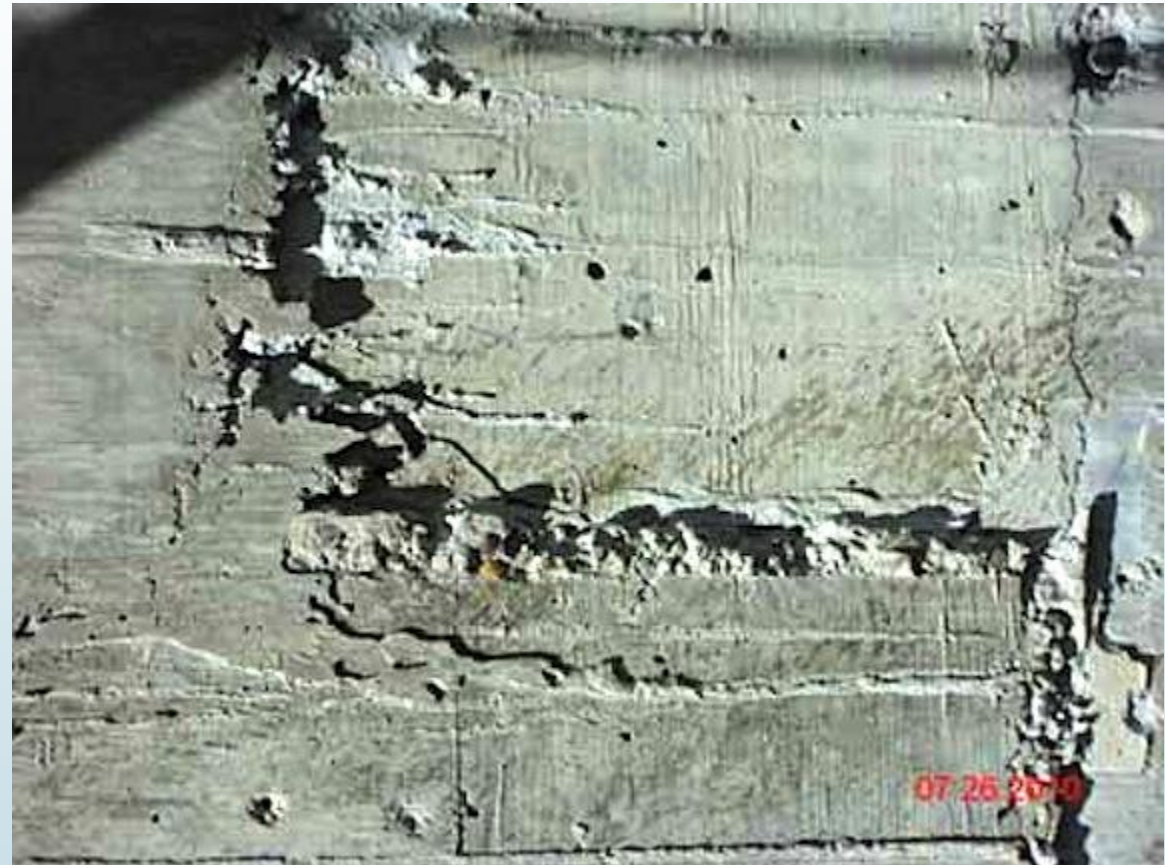
Cold joints are created when concrete is poured against concrete that has already hardened to some degree. This condition results in a weakened bond between the existing and the newly poured concrete

Fig. 22. Cold Joint in Concrete

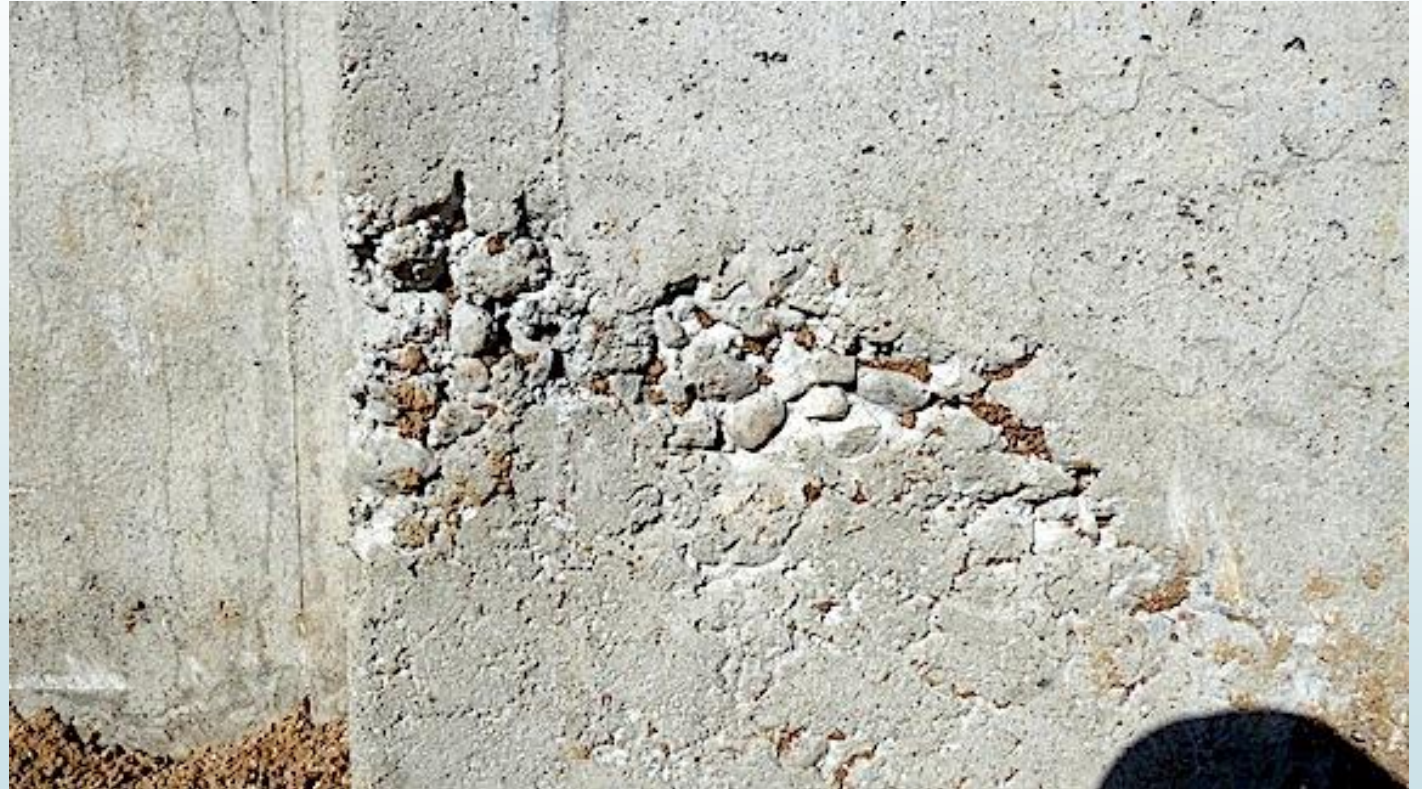
Honeycombing is the term used to describe areas of the surface that are coarse and stony. It may be caused by insufficient fine material in the mix, perhaps due to incorrect aggregate grading or poor mixing. This can be corrected by increasing the sand and cement content of the mix and by proper mixing, placing and compaction.

Fig. 23. Honey-combing due to improper consolidation

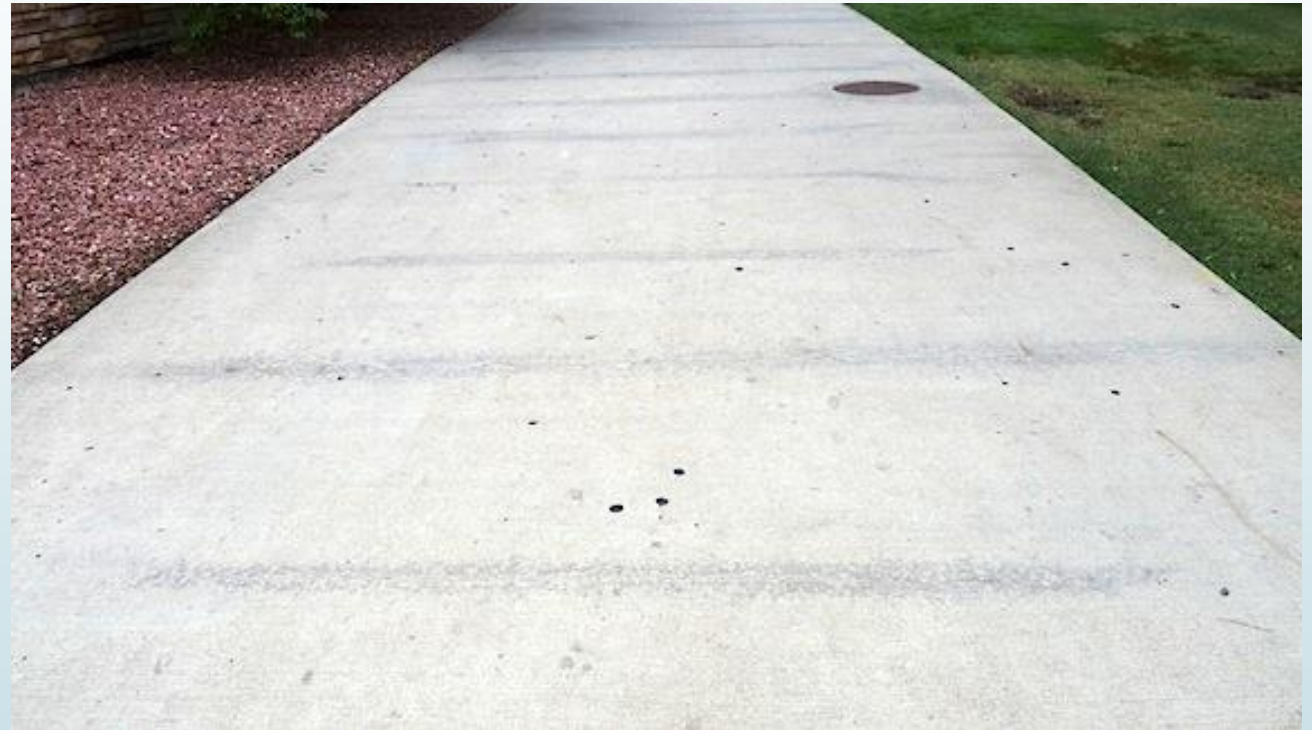
Plastic settlement can be caused by subsidence around rebar. As soon as concrete is placed, it begins to consolidate, and as bleed water rises to the surface, cement particles consolidate and the concrete settles. The settling process is restrained by reinforcement steel and, under certain circumstances, cracks will develop directly above the steel.

Fig. 23. Plastic Settlement Cracking

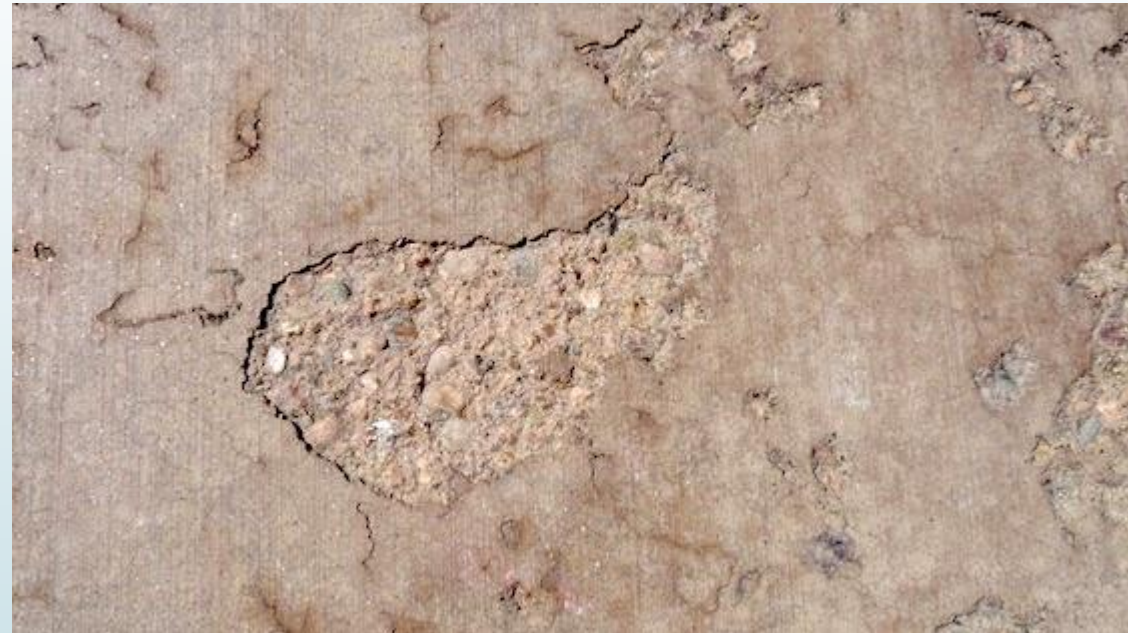
Scaling is the shedding of flakes of hardened concrete at the surface. It can be caused by a number of conditions.

Fig. 24. Scaling of Concrete

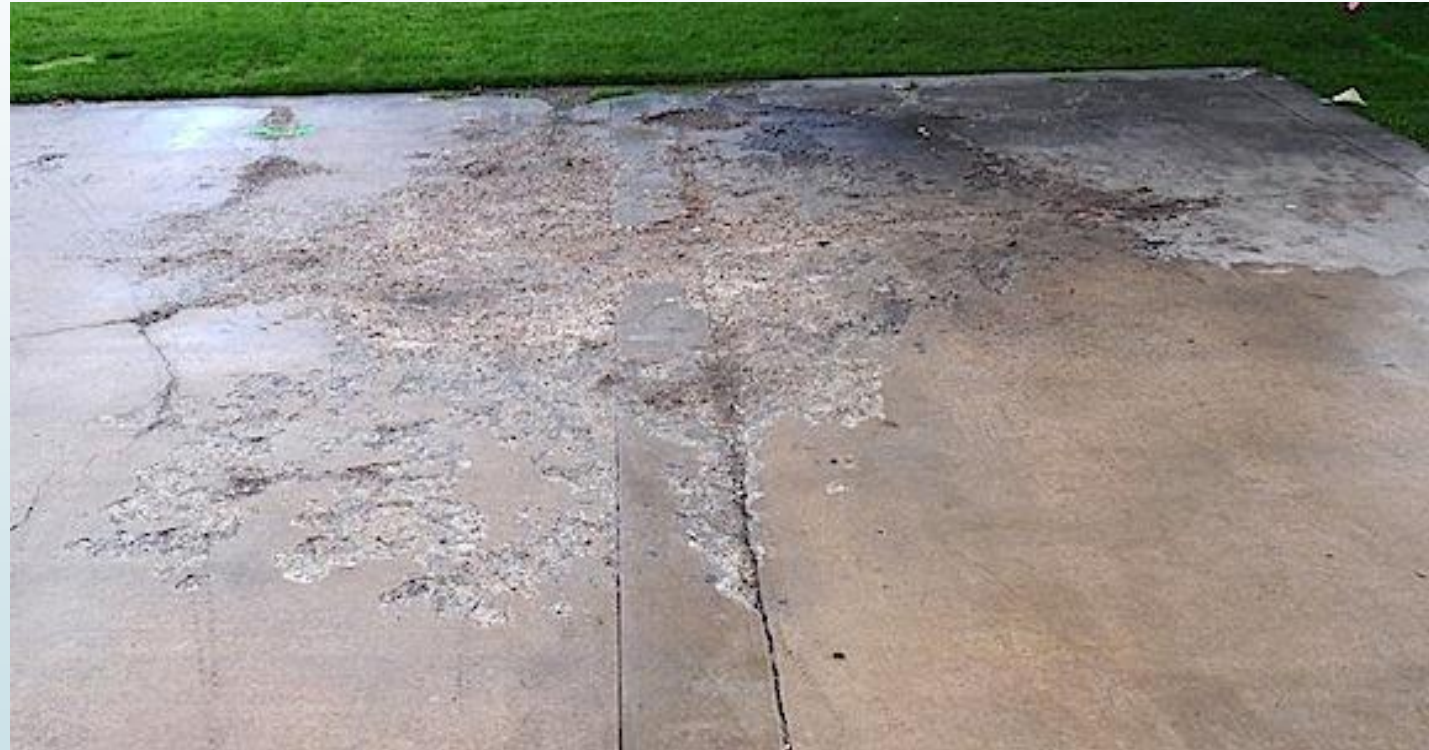
Typically occurs due to freeze-thaw cycles, application of de-icing salts and early finishing of the concrete even before bleeding is completed.

Fig. 25. Scaling and dusting of Concrete

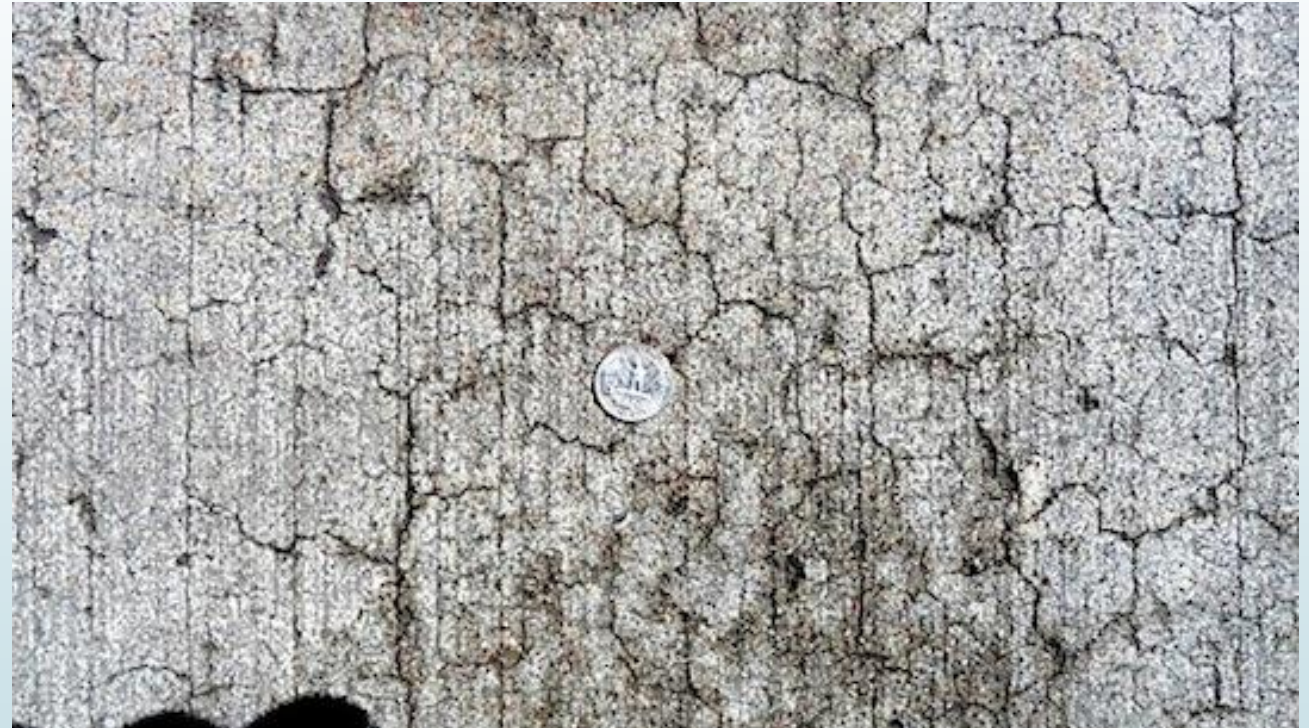
Crazing: Pattern cracking, also called map cracking and craze cracking, appears as a network of random cracking on the concrete's surface. The cracking is usually shallow (less than 1/8-inch deep) and not a structural issue. It's seldom a durability problem but more of a cosmetic one.

Fig. 25. Crazing Cracks

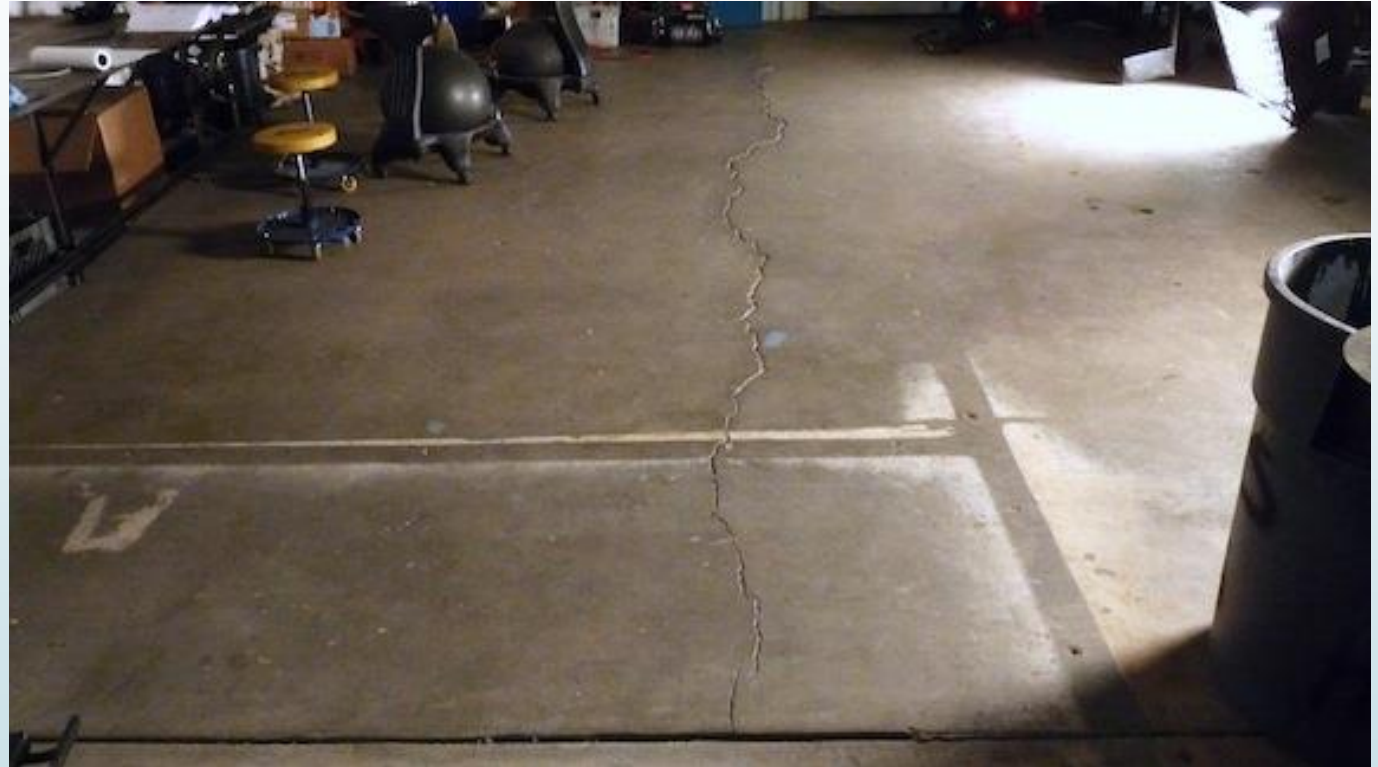
Drying shrinkage is shrinkage that takes place after the concrete has hardened and some degree of bonding has developed between the cement paste and the aggregate. As concrete continues to dry, it will continue to shrink. Drying shrinkage includes both shrinkage that takes place while losing moisture to the air and autogenous shrinking, as noted previously.

Fig. 26. Drying Shrinkage Cracks

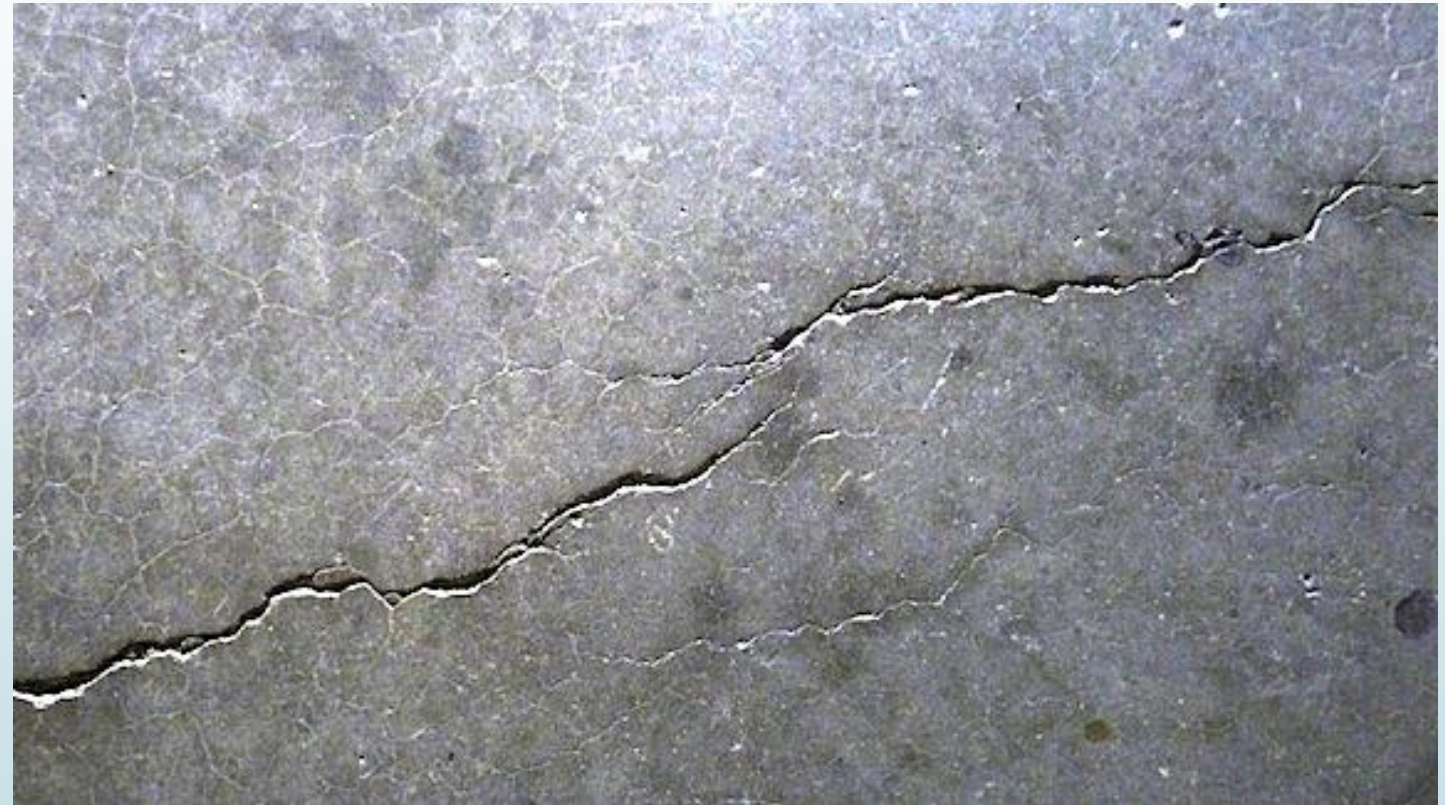
Drying shrinkage cracks need not be continuous

Fig. 27. Drying Shrinkage Cracks (Discontinuous)

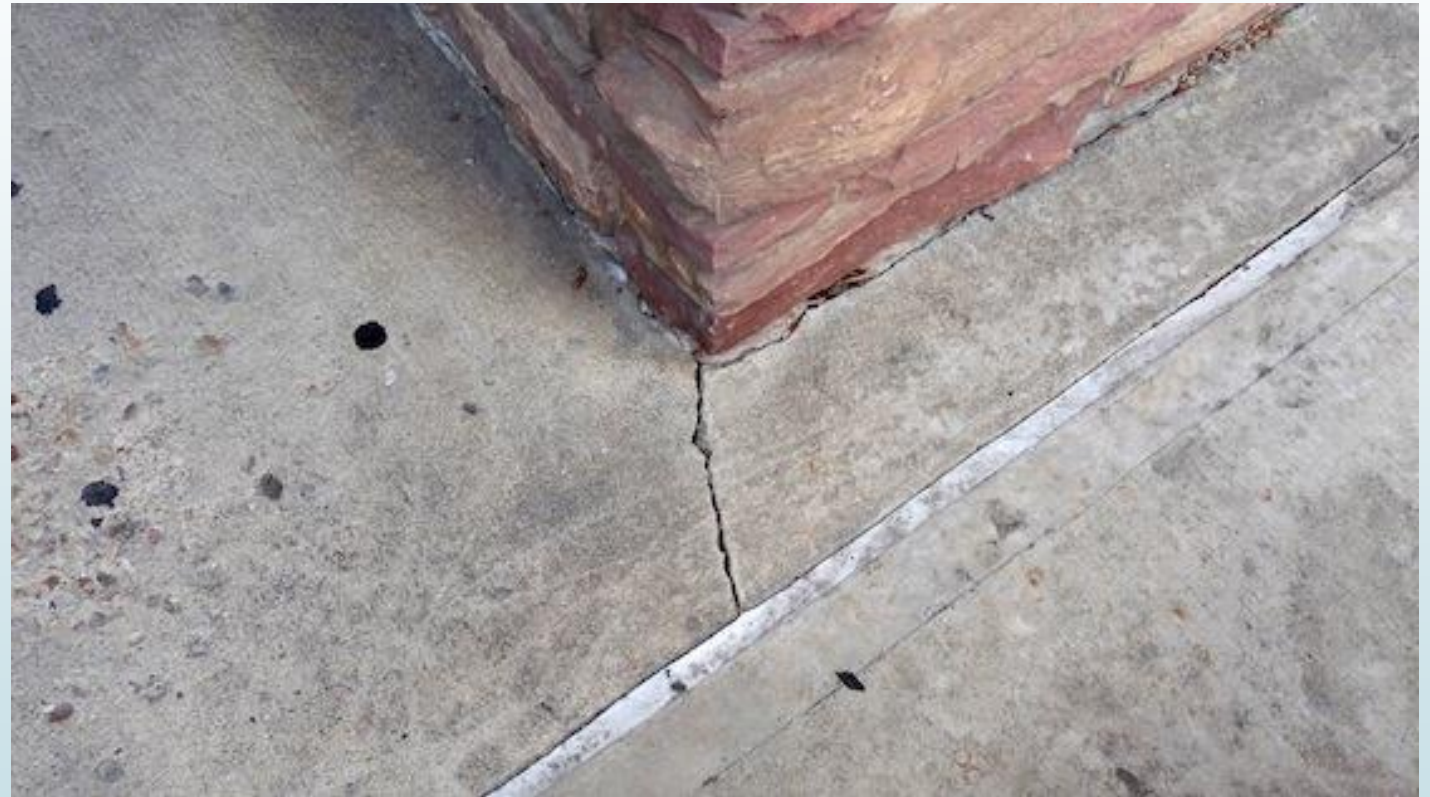
A re-entrant corner is where any inside corner forms an angle of less than 180 degrees into the body of the slab. As the concrete dries and shrinks, the wedge shape of the re-entrant corner encourages concrete to crack off the point of the angle into the slab.

Fig. 29. Re-entrant corner cracks

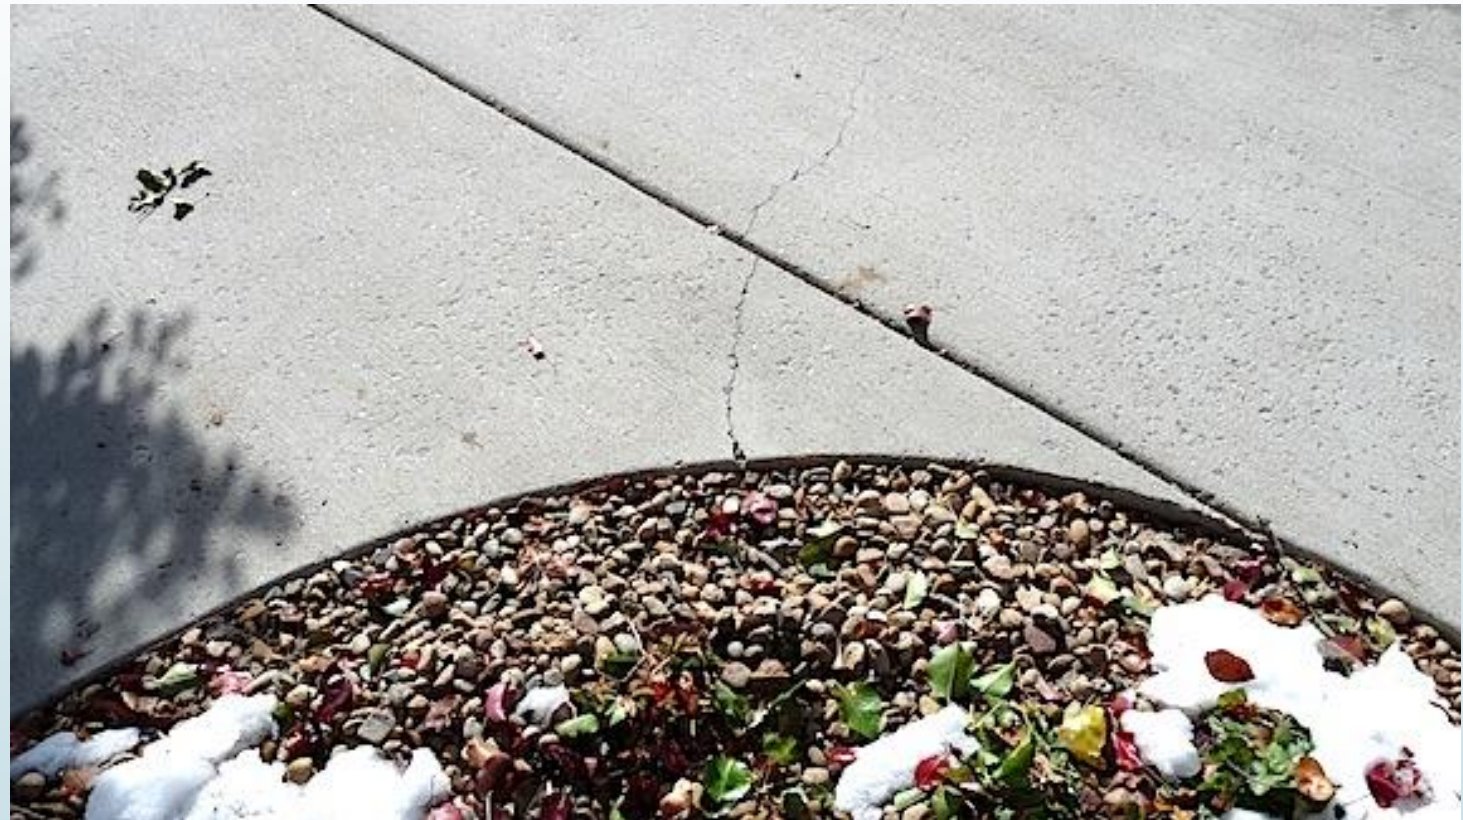
A re-entrant corner is where any inside corner forms an angle of less than 180 degrees into the body of the slab. As the concrete dries and shrinks, the wedge shape of the re-entrant corner encourages concrete to crack off the point of the angle into the slab.

Fig. 30. Re-entrant corner cracks

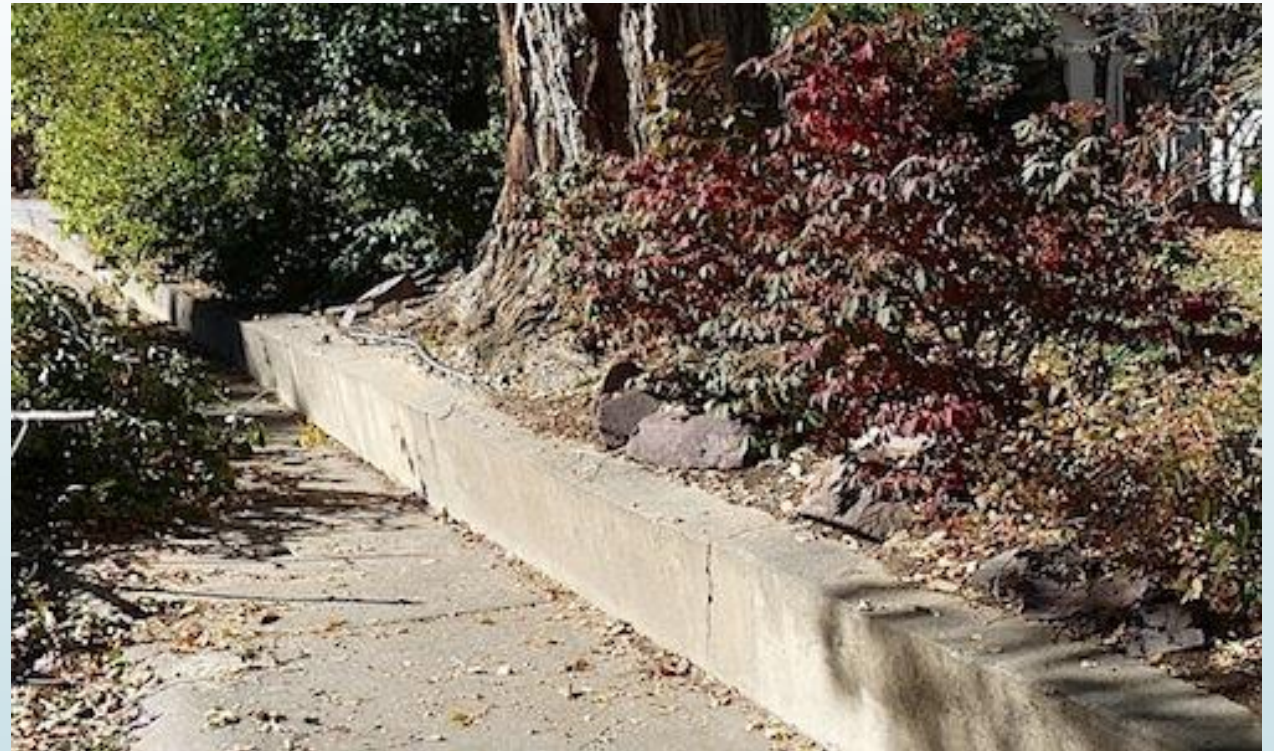
Deformation and cracking under load sustained over a long period of time.

Fig. 31. Creep with cracks

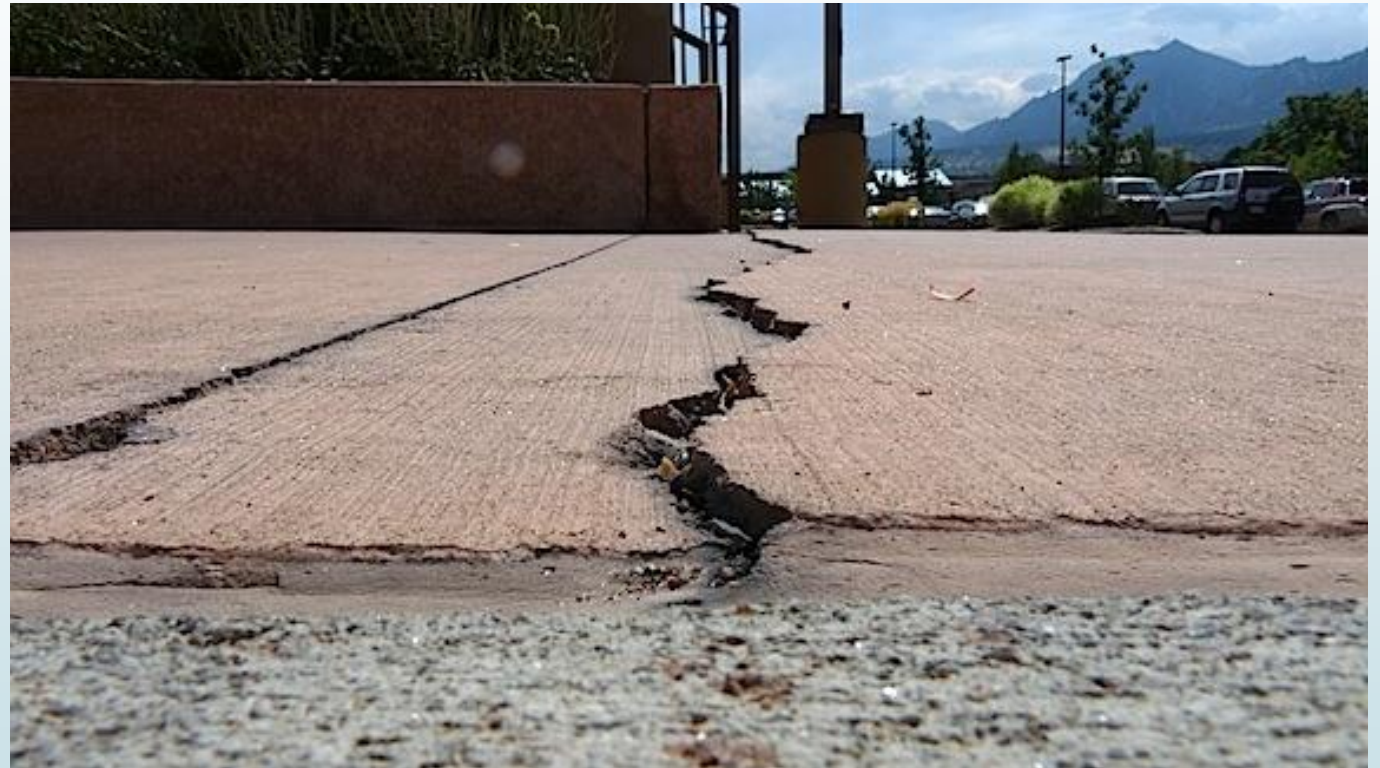
Due to improper compaction or preparation of the subgrade, possibility of differential settlement of sub-grade exists. Due to this, the overlying concrete pavement or slab develops cracks.

Fig. 32. Differential Settlement Cracks

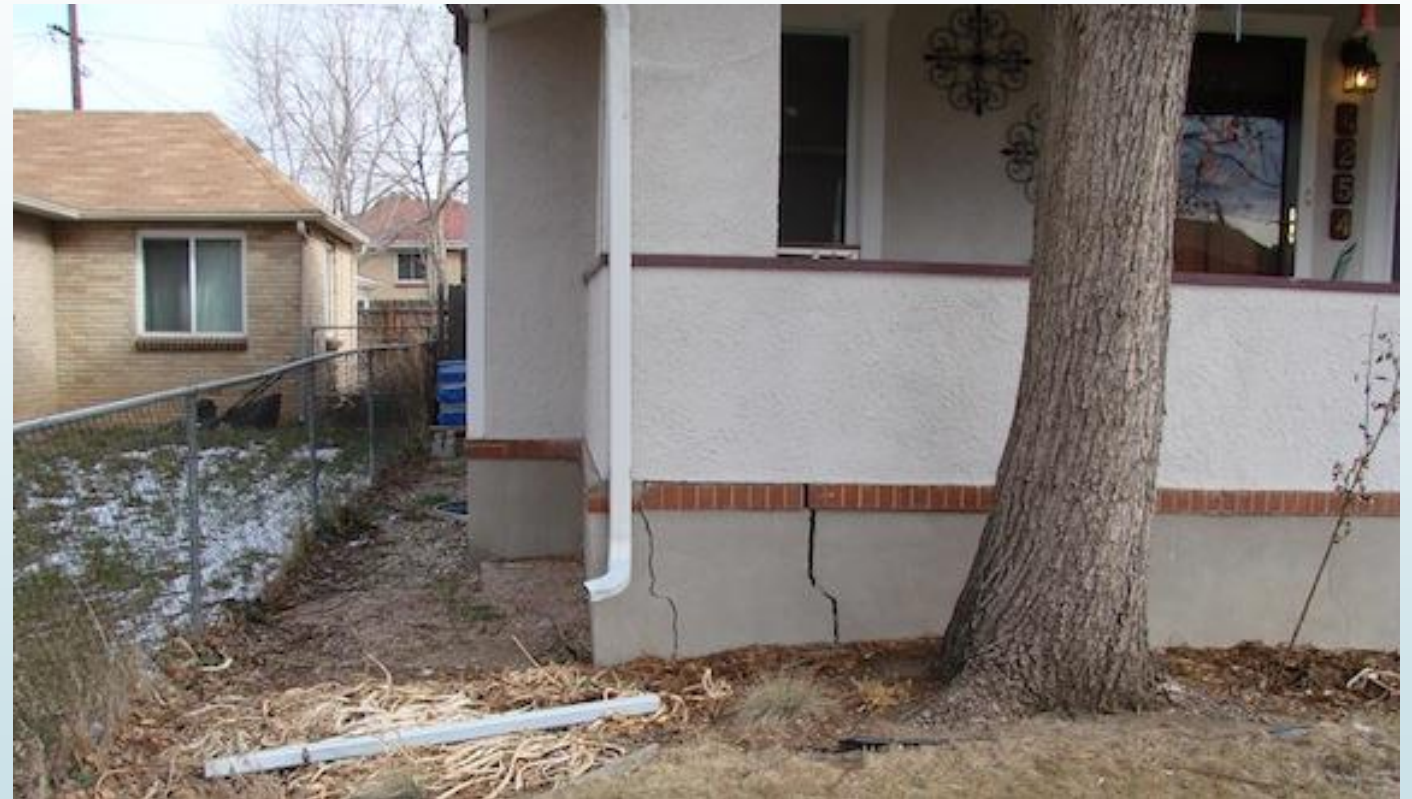
Soil with poor load-bearing capacity allows settling.

Fig. 33. Masonry cracks due to Differential Settlement

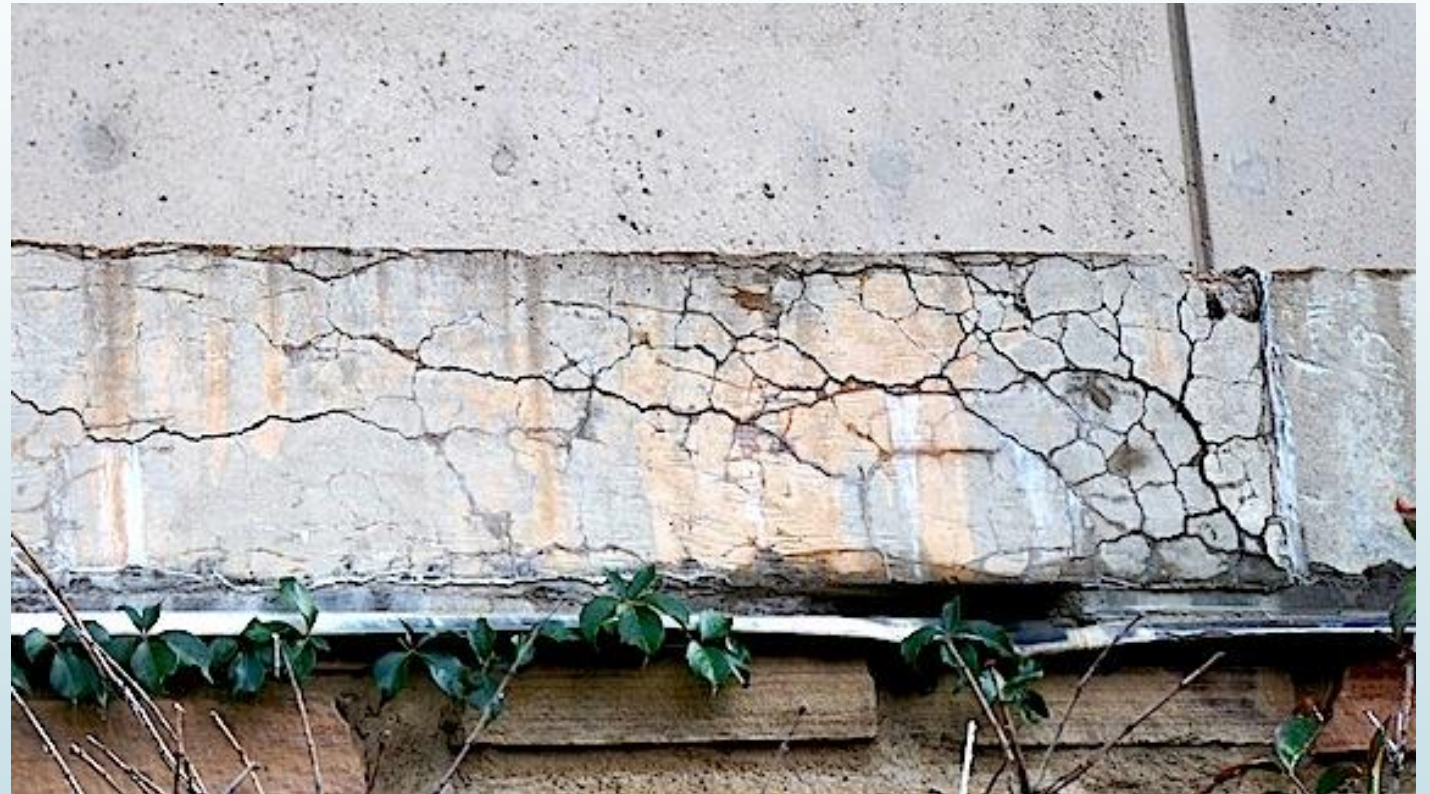
To confirm AAR, further laboratory investigations will be required.

**Fig. 34. Cracks Pattern due to chemical action
– Possibly Alkali Aggregate Reaction (AAR)**

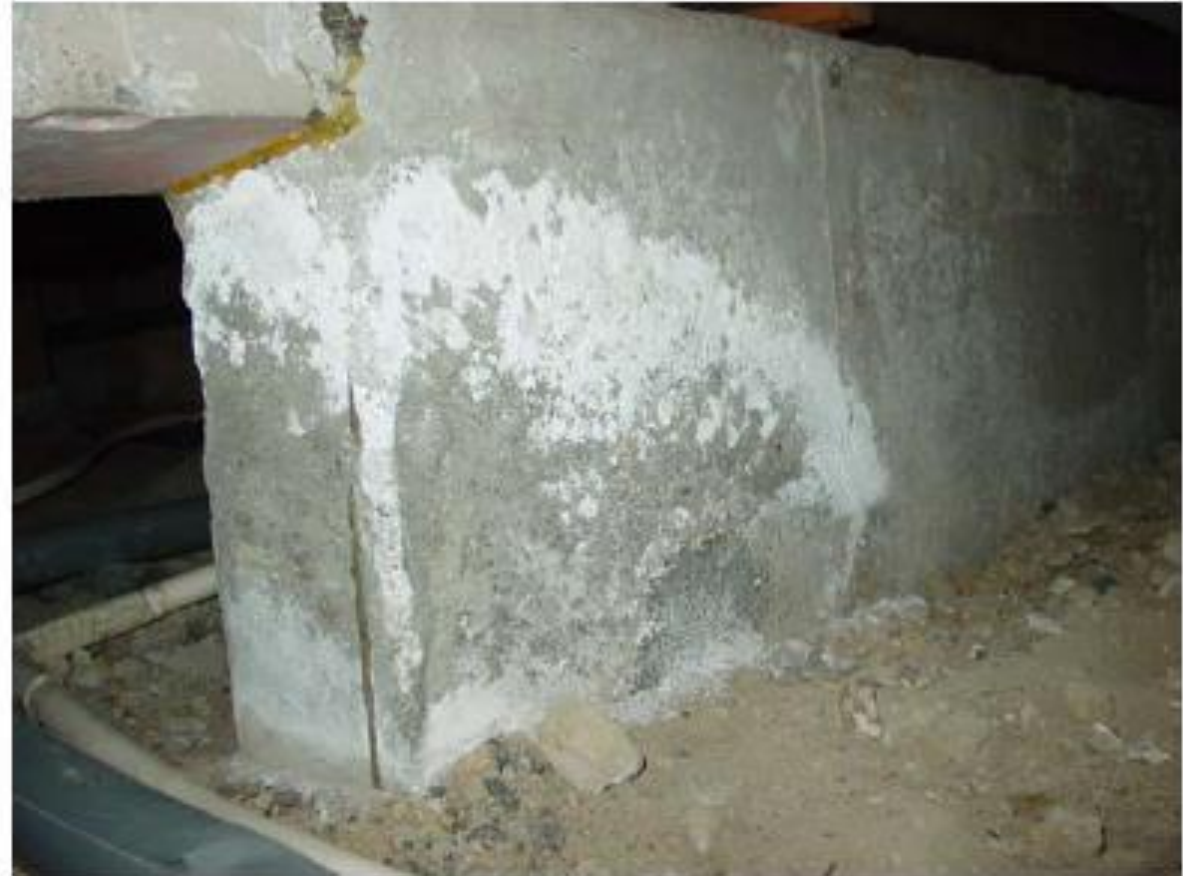
Physical sulphate attack is often evidenced by bloom (presence of sodium sulphate salts) at exposed concrete surface. It is not only a cosmetic problem but the visible display of possible chemical and micro-structural degradation within the concrete.

**Fig. 35. Damage Pattern due to chemical action
- Sulphate Attack**

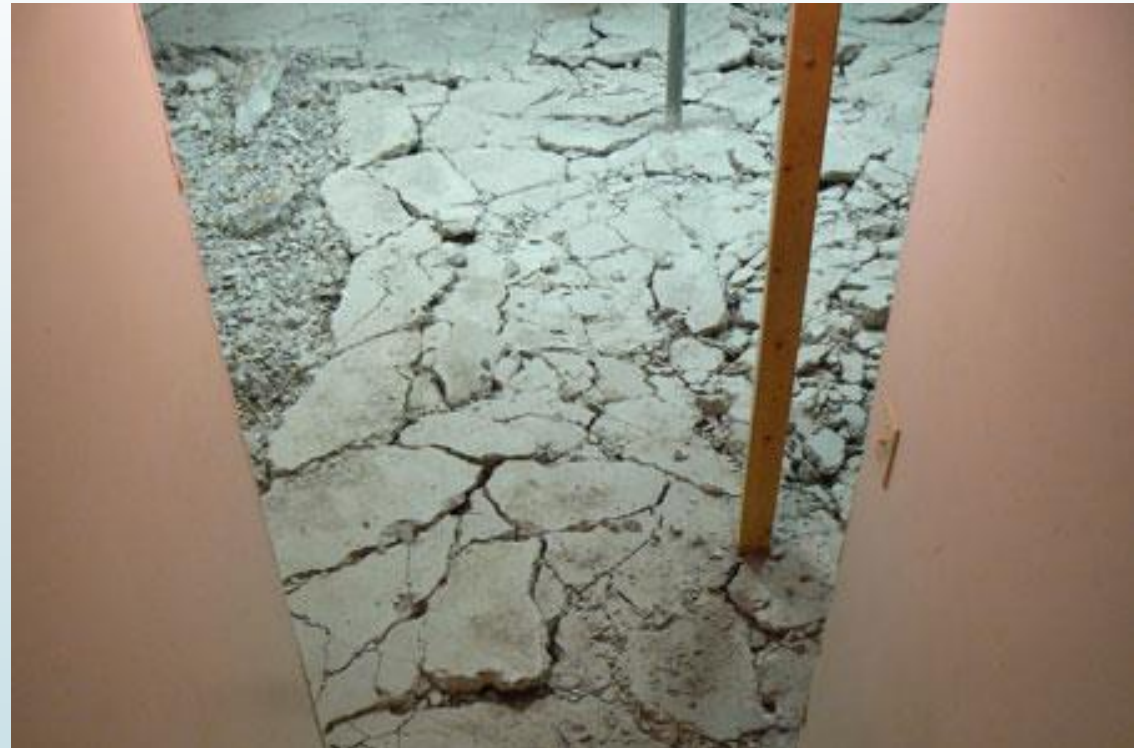
The concrete floor in question was under severe sulphate attack. Due to the underlying soil conditions, the ingress of moisture started the reaction.

**Fig. 36. Cracks Pattern due to chemical action
– Sulphate Attack**

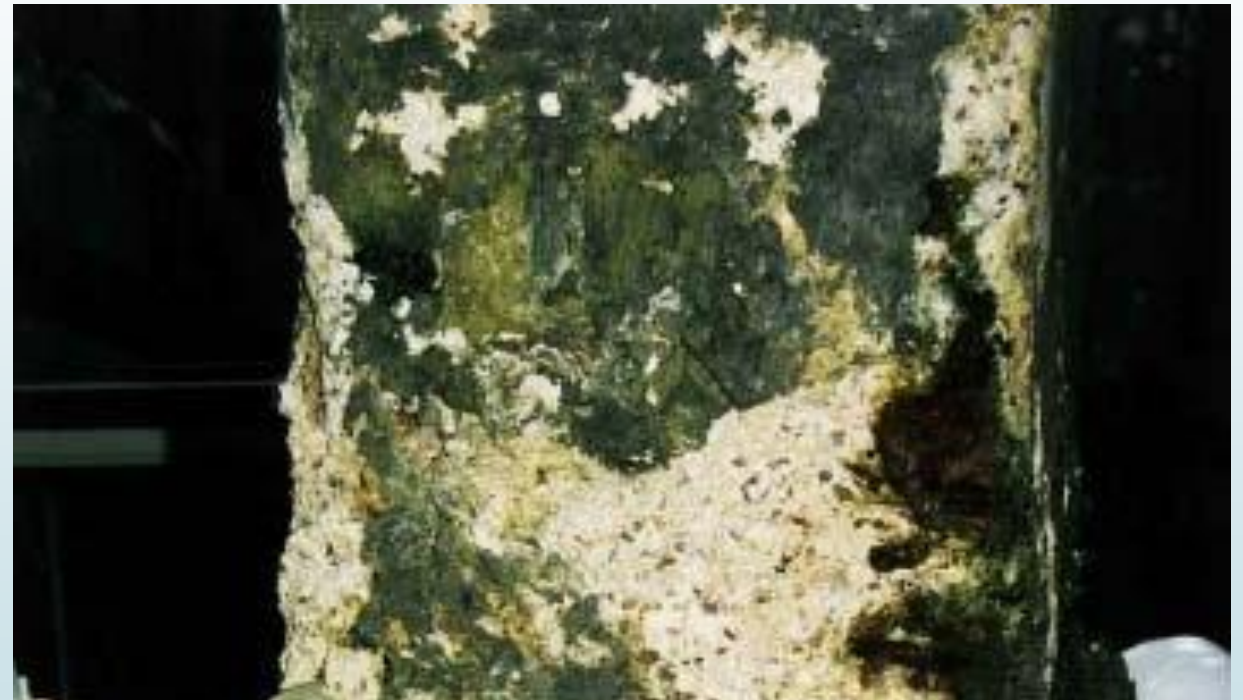
Severe Sulphate Attack due to exposure of the pillar to sea water.

**Fig. 37. Deterioration due to chemical action
- Sulphate Attack**

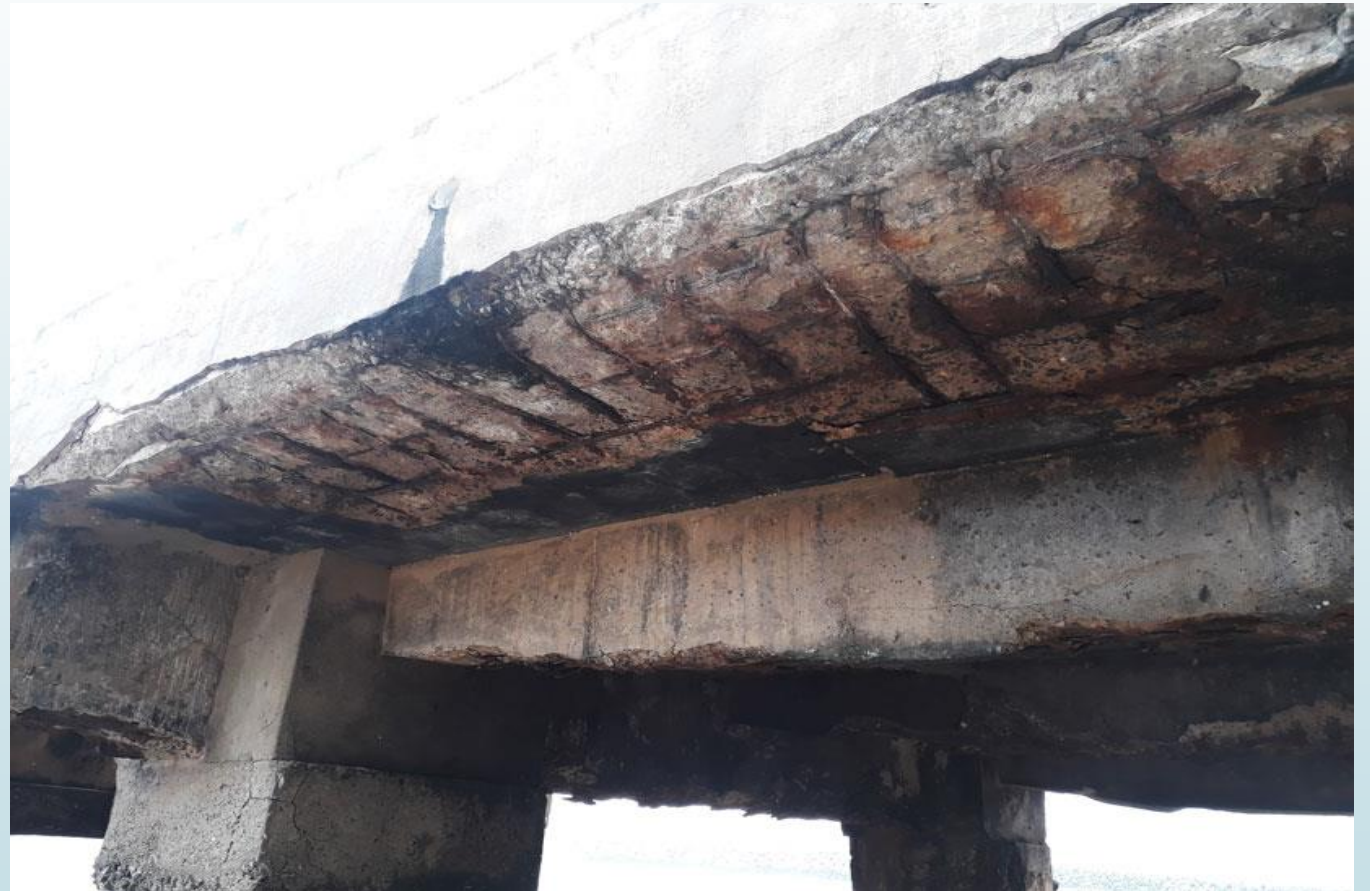
Corrosion of reinforcing steel causes spalling of the cover concrete

Fig. 38. Spalling due to Reinforcement Corrosion

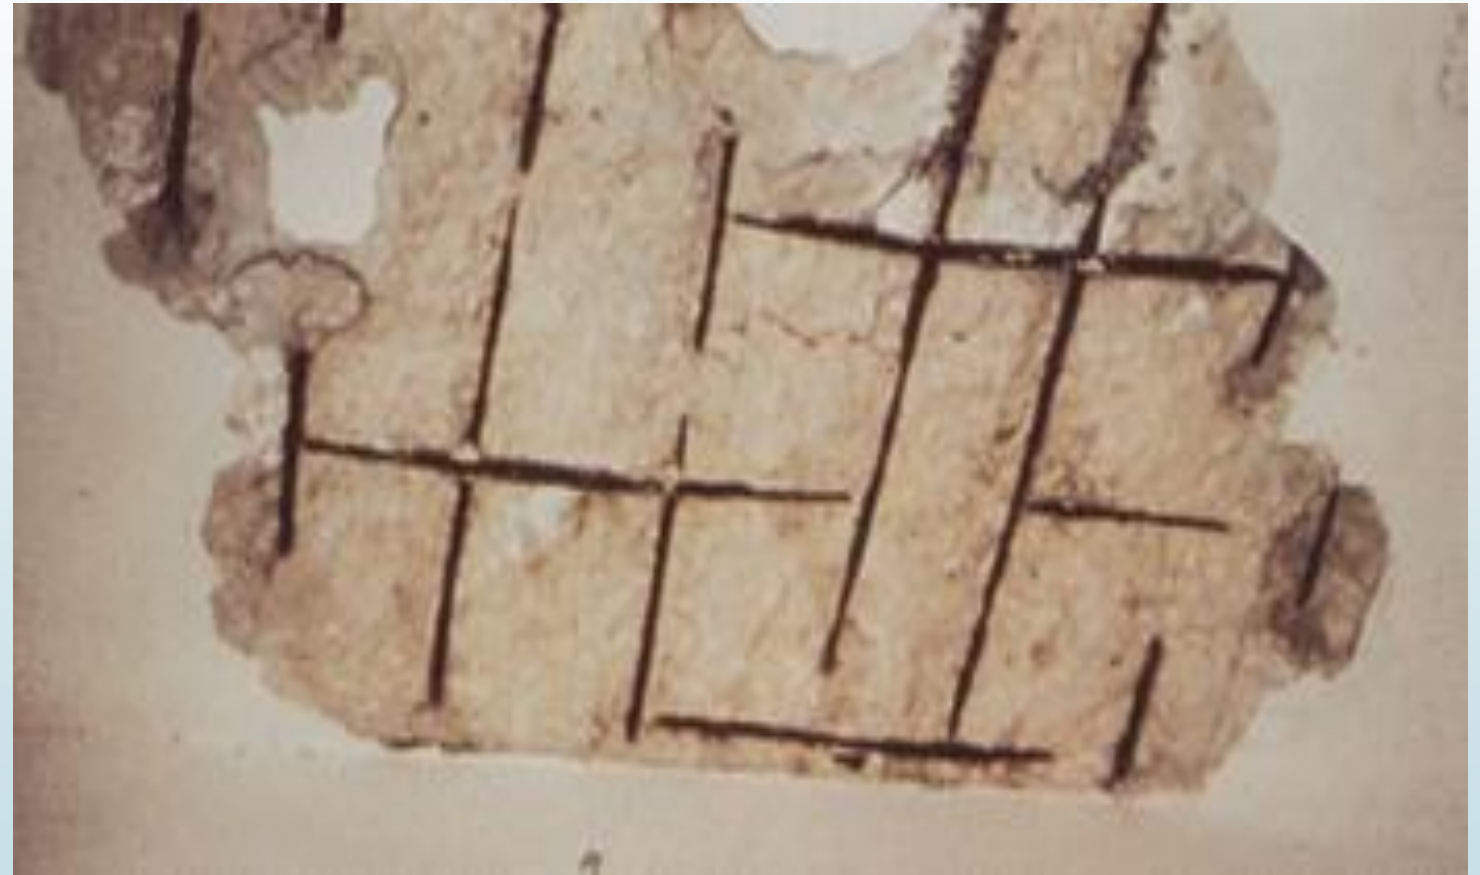
Fig. 39. Spalling due to Reinforcement Corrosion
