Course: PE 821 CE RETROFITTING AND REHABILITATION OF STRUCTURES

University College of Engineering, Osmania University

UNIT III

Condition Assessment, Non-Destructive Testing and Evaluation

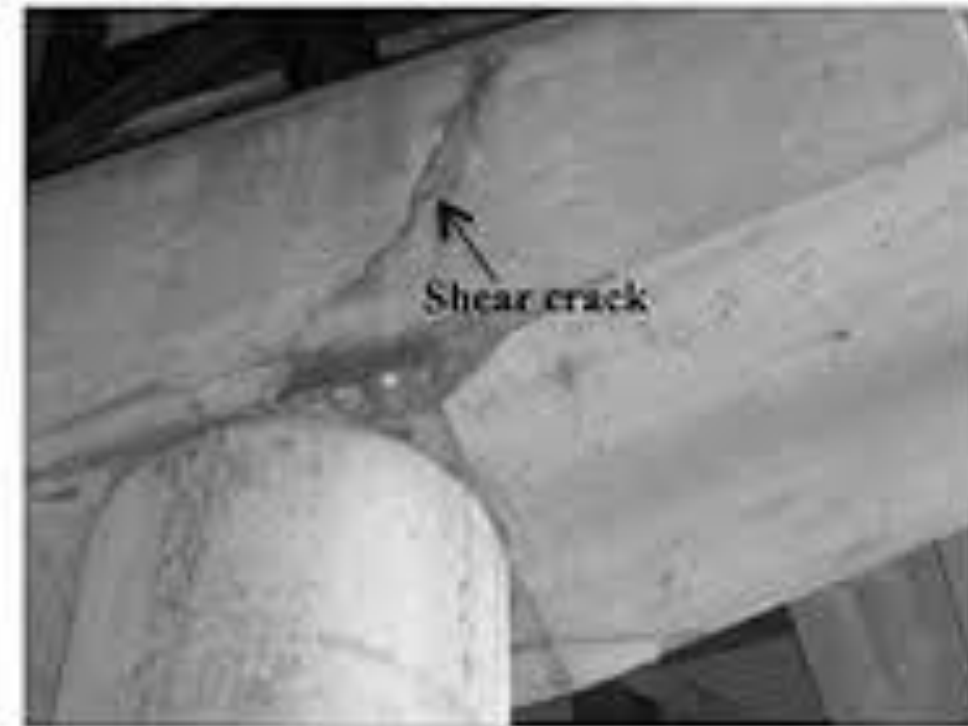
Fig. 40. Crack due to excessive loading
